## Failure investigation of forming rolls made of Si<sub>3</sub>N<sub>4</sub>

**Keywords:** Silicon nitride, forming rolls, failure examination

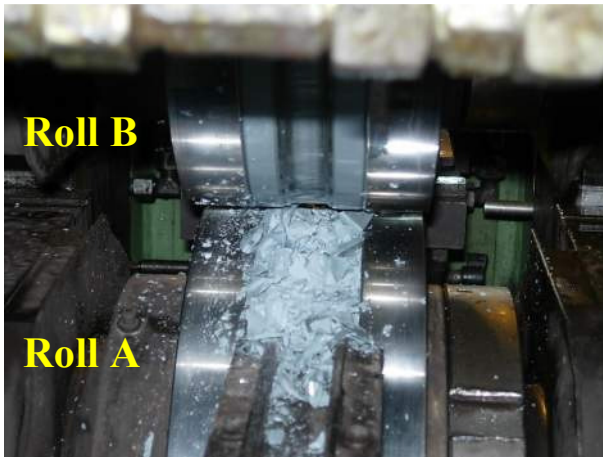
Fig. 1 shows the failure in the rolling mill at Böhler-Profil. The silicon nitride ring is 50 mm wide, has an outside diameter of 350 mm and an inside diameter of 280 mm. The ceramic rings are clamped between a ring flange and a fixed flange (hub), both made of high grade steel. The ring flange is bolted down onto the hub using eight 8 mm socket head screws. In application the roll pressure can reach 60 tons, and the temperature of the rolled wire is between 600 °C and 800°C.

**Fig. 1:** Forming rollers after fracture (photo: Böhler)

**Roll A:** The failure of Roll A is not a consequence of cracks introduced by metal contact through the forming process. The reason for the failure is the occurrence of hoop tensile stresses around the inner surface of the roll. After the principal transverse fracture, the opening of the ring resulted in fracture into several large fragments. The final fragmentation seen in Fig.1 would result from there being several dislodged large fragments interfering with the rolling process.

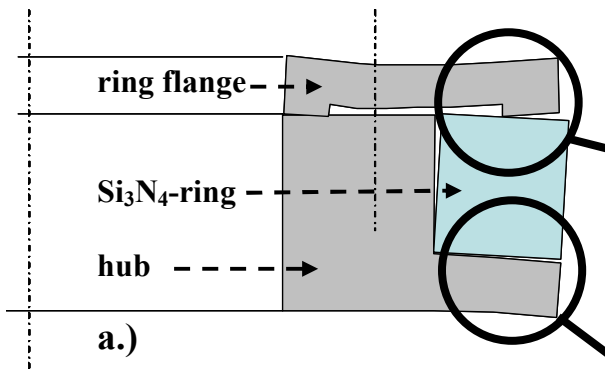
**Fig. 2a:** Sketch of the clamping of the roll after tightening the screws. When the screws are tightened the ring flange distorts and bends slightly. The hub is forced also to bend outwards.

One roll (A) has completely shattered into a few large and many small fragments, the second roll (B) has failed from a single spalling fracture. In both rolls (A and B) the pattern of metal contact with the ceramic was the same. From the sketch of the clamping of the roll (Fig. 2a) can be recognized that the clamping was not uniform. There is a narrow band of contact on the ring flange side (Fig. 2b). On the other side (the hub side) it can be seen that there is primary contact over an area about half the radial width of the roll (fig. 2c). On the inside surface of the roll metal transfer onto the machined surface profile can be seen.

There is a strong probability that the hoop tensile stresses causing the initial radial fracture are due to thermal expansion mismatch between the hub and the roll. If the designed clearance between the hub and the ceramic part is insufficient, a general rise in temperature of the entire hub system in service might result in closure of the gap followed by the application of an internal bursting pressure on the roll. The expansion coefficient mismatch between the metal hub and the ceramic is about  $13 \times 10^{-6} \text{ } ^\circ\text{C}^{-1}$ . If the clearance is 0.05 mm (this is typical for other systems) the temperature rise to close the gap on a 140 mm inside radius would be only  $0.05/(140 \times 0.000013) \approx 27^\circ\text{C}$ . For

greater temperature rises most of the extra mismatch would go into stressing the ceramic. A temperature rise of 100°C can be estimated to cause a hoop stress of around 200 MPa in the ceramic compared with the stress at fracture by a mirror analysis of approximately 250 MPa.

1. To reduce the risk of hoop tension break-up the room-temperature clearance between the roll and the hub should be increased by an amount sufficient to allow the closure of the gap during heating the working hub temperature.
2. The second modification is to the flange designs in such a way that axial clamping onto the ceramic roll takes place preferentially at the outer edge of the roll. The flange contact regions have to be suitably profiled to allow for the inevitable elastic distortion. Then the axial compressive force could be maximised across the roll outer surface, and not well below it as at present. This should help to restrict the propagation of cracks from the profile corners and prevent flakes from developing and breaking off.

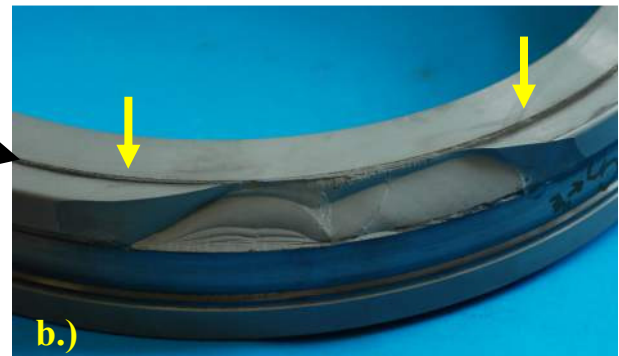
**Fig. 2b:** Contact zone with the area of metal clamping in roll B. The narrow band of contact can be seen in the middle of the roll (arrows).

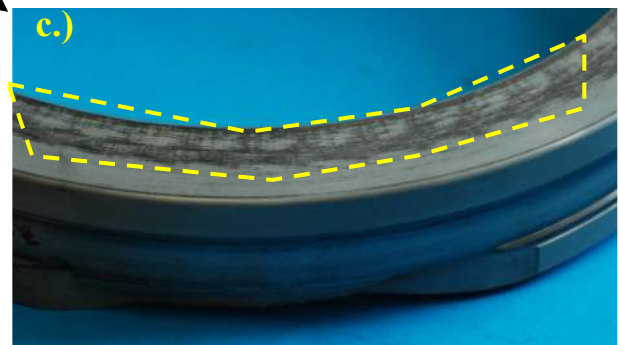
**Fig. 2c:** Opposite side of roll B with the metal contact zone (marked by the dashed polygon).

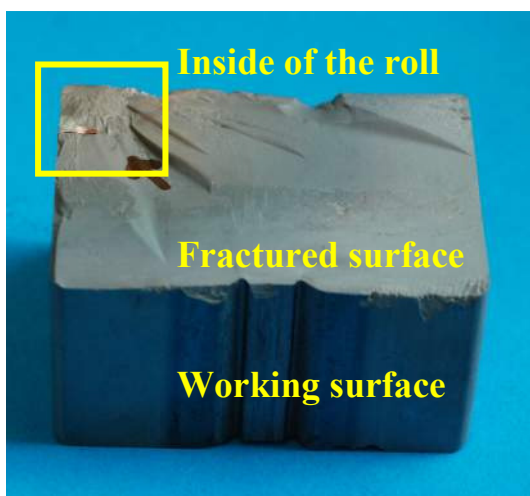
**Fig. 3a:** Macro-view from fractured piece No. 1 after coating for a SEM-examination. The mirror can be found on the inside surface near the edge (rectangle).

In Roll A, among the extensive fragmentation a clear transverse fracture was found (Fig. 3a). In the stereo microscope a clear semicircular mirror can be seen (Fig. 3b).

The large-sized chip (marked by an arrow) is a secondary edge chip. The area where the fracture origin is situated is marked by a rectangle. In the SEM a porous region below the surface (Fig. 3c) was found, but this area seems too small to act as a fracture origin. Therefore it is thought that the fracture origin may be a hoop loaded machining crack.

If the mirror constant [8] is estimated as  $8 \text{ MPa m}^{1/2}$ , the mirror radius indicates the stress at fracture was about 250 MPa.

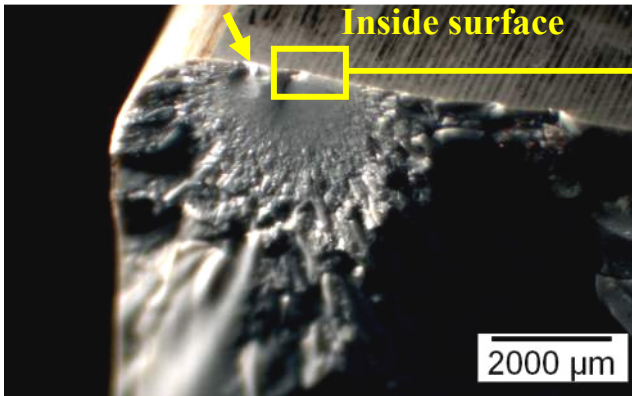
**Fig. 3b:** Part of the fracture surface of fragment 1 with the mirror in the stereo microscope.

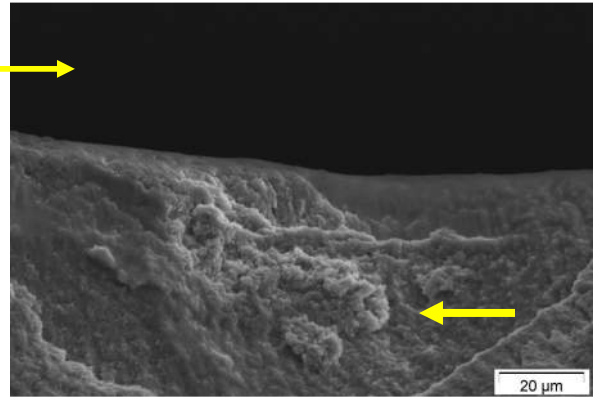
**Fig. 3c:** SEM-micrograph of the fracture origin. The porous zone (arrow) below the surface seems to be too small to act as a fracture origin.

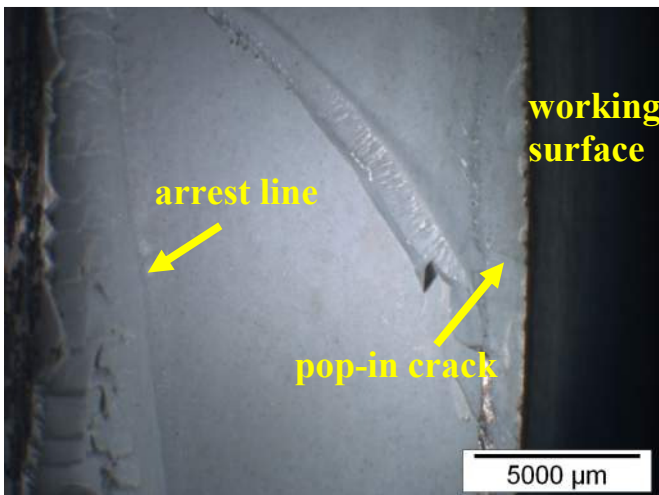
**Fig. 4:** Detail of the right hand flake of roll B.

In contrast, Roll B has failed non-catastrophically by the production of two flakes which commenced from the radii at the profile sides in the working face. The crack morphology suggests that the flakes developed from a short pop-in crack in the side of the profile over several cycles of loading and then final broke off across the short ligament of remaining material near the contact line on the side of the ring flange side.

Fig. 4 shows a detail of the right hand flake. Here the region of pop-in from the corner of the profile is still visible.

However, on the periphery of the contact zone large tensile stresses are expected to occur. Hertz calculated these stresses between a sphere and an infinite half plane [10, 11]. Such stresses were analysed with a 3D-FE model in [6, 7]. It was found that the Hertzian stresses, which can reach about 1/6 of the mean compressive stresses, occur near the surface and decrease rapidly in the depth. Therefore, for short surface cracks the stress intensity factor reaches a maximum and decreases for longer cracks. As a result of this behaviour pop-in cracks come into being but stop after a short distance. Unless these unavoidable pop-in cracks are pinned by appropriate lateral stressing they can develop into edge flakes.
